NAD C390DD start-up issue

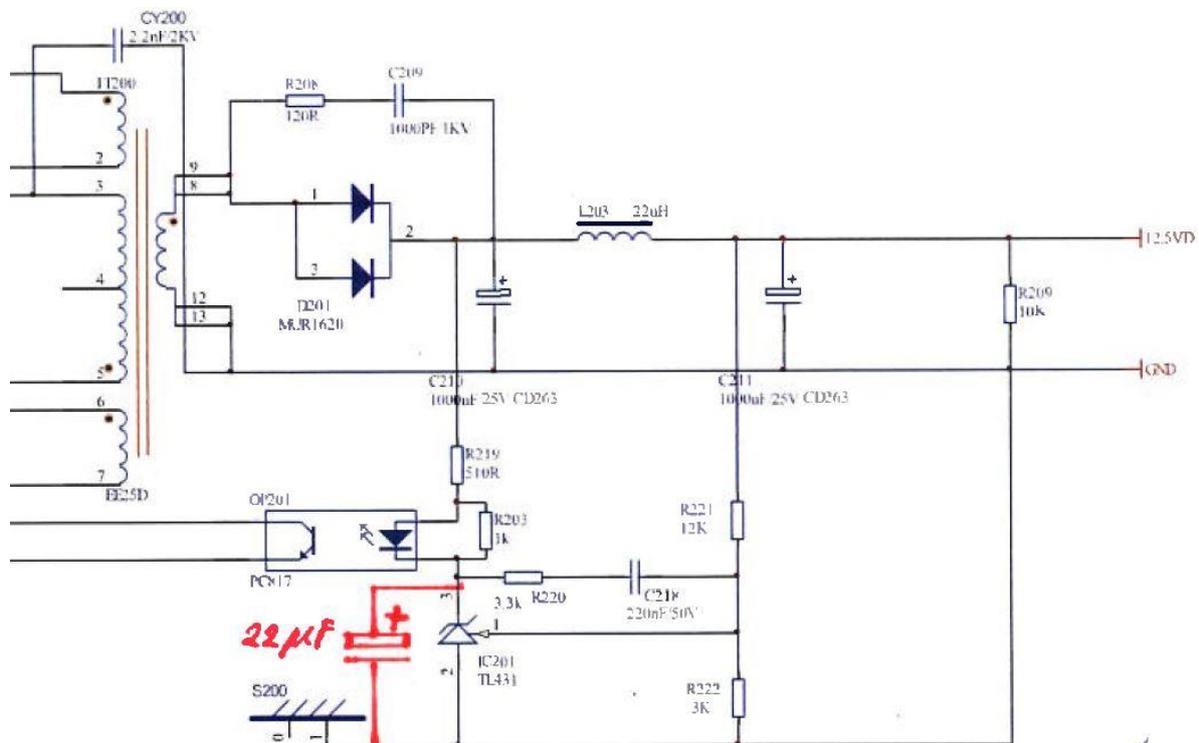
Once relay K200 is in, the upper part of the schematic of PSU-B, built around the TOP246Y should start working. This then will provide the 12.5VD. However, this does not always happen. The 12.5VD supplies, via a number of dedicated linear voltage regulators which provide lower voltages, large parts of the amplifier like the Zetex FPGA board, input selection, USB card and optional plug in cards. It looks as if this supply does not always start up properly. It may depend also on how many plug-in modules are used. In my case, I have the HDMI module and the analog module. These optional modules increase the load on this supply.

The purpose of the soft finish capacitor is to ensure that the power supply actually starts up. From PI: “Soft finish helps our devices to get (already) a feedback signal before soft-start finishes (soft start takes 10 ms) when there is huge output capacitance or heavy load at startup.” In this case of the C390DD the output capacitance is $2 \times 1000 \mu\text{F}$. The presence of the soft finish capacitor enables a (additional) current through the LED of the optocoupler during start up. This current charges the elcap, and once the TL431 zener voltage is reached, the soft finish elcap doesn't have much effect anymore. However, since the elcap ensures an initial current through the LED of the optocoupler, during that time also a current will flow in the control input of the TOP246Y. This device provides a fully integrated 10 ms soft-start, which limits peak currents and voltages during start-up and dramatically reduces or eliminates output overshoot in most applications. However, if no external feedback/supply current is fed into the CONTROL pin by the end of the soft-start, the high voltage current source is turned off and the CONTROL pin will start discharging in response to the supply current drawn by the control circuitry. This then results in no start-up of the supply, and to prevent this from happening the ‘soft finish’ elcap has been added. I have seen several values being used by Power Integrations, mostly $22 \mu\text{F}$ but I have also seen designs with $47 \mu\text{F}$. I have opted to use $22 \mu\text{F}$ here.

information about a so-called soft finish capacitor that can be added to the design in order to improve startup behavior. The simplest implementation is to add just one elcap in parallel with the TL431 (IC201), pins 2 (minus) and 3 (positive). This is indicated in red in the schematic below.

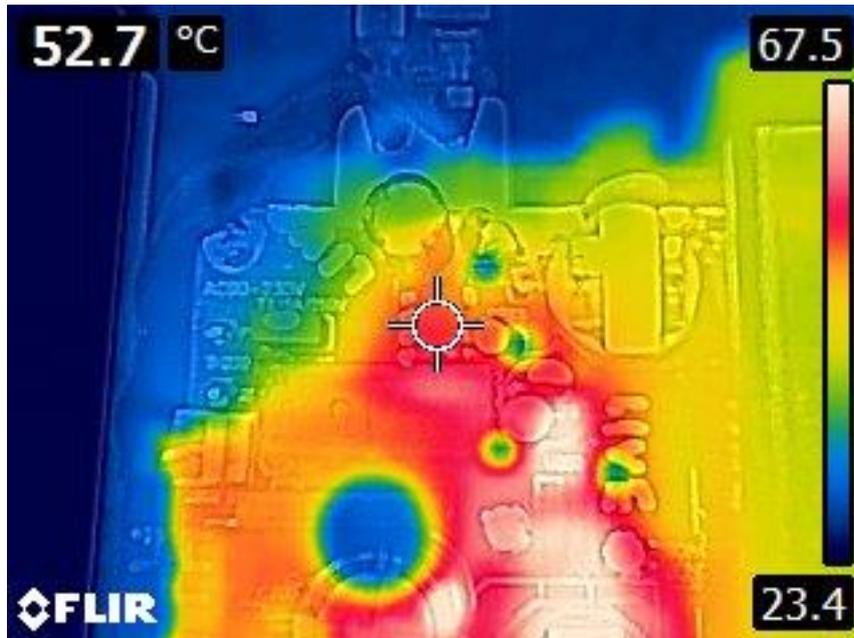
As a result I do not know what causes this sound which happens occasionally. I think it has always been there. In order to check whether something runs too hot in this mode I used a thermal camera to compare the temperatures in normal mode and in the mode when this happens. See below.

In both situations the temperature distribution and actual temperatures are the same. Therefore I have stopped to look further into it.
