## LUX Audio of America Ltd.

April 26, 1978

TO: ALL LUX SERVICE STATIONS

SUBJECT: ADJUSTMENT FOR UNSTABLE SPEED ON PD-441/PD-444

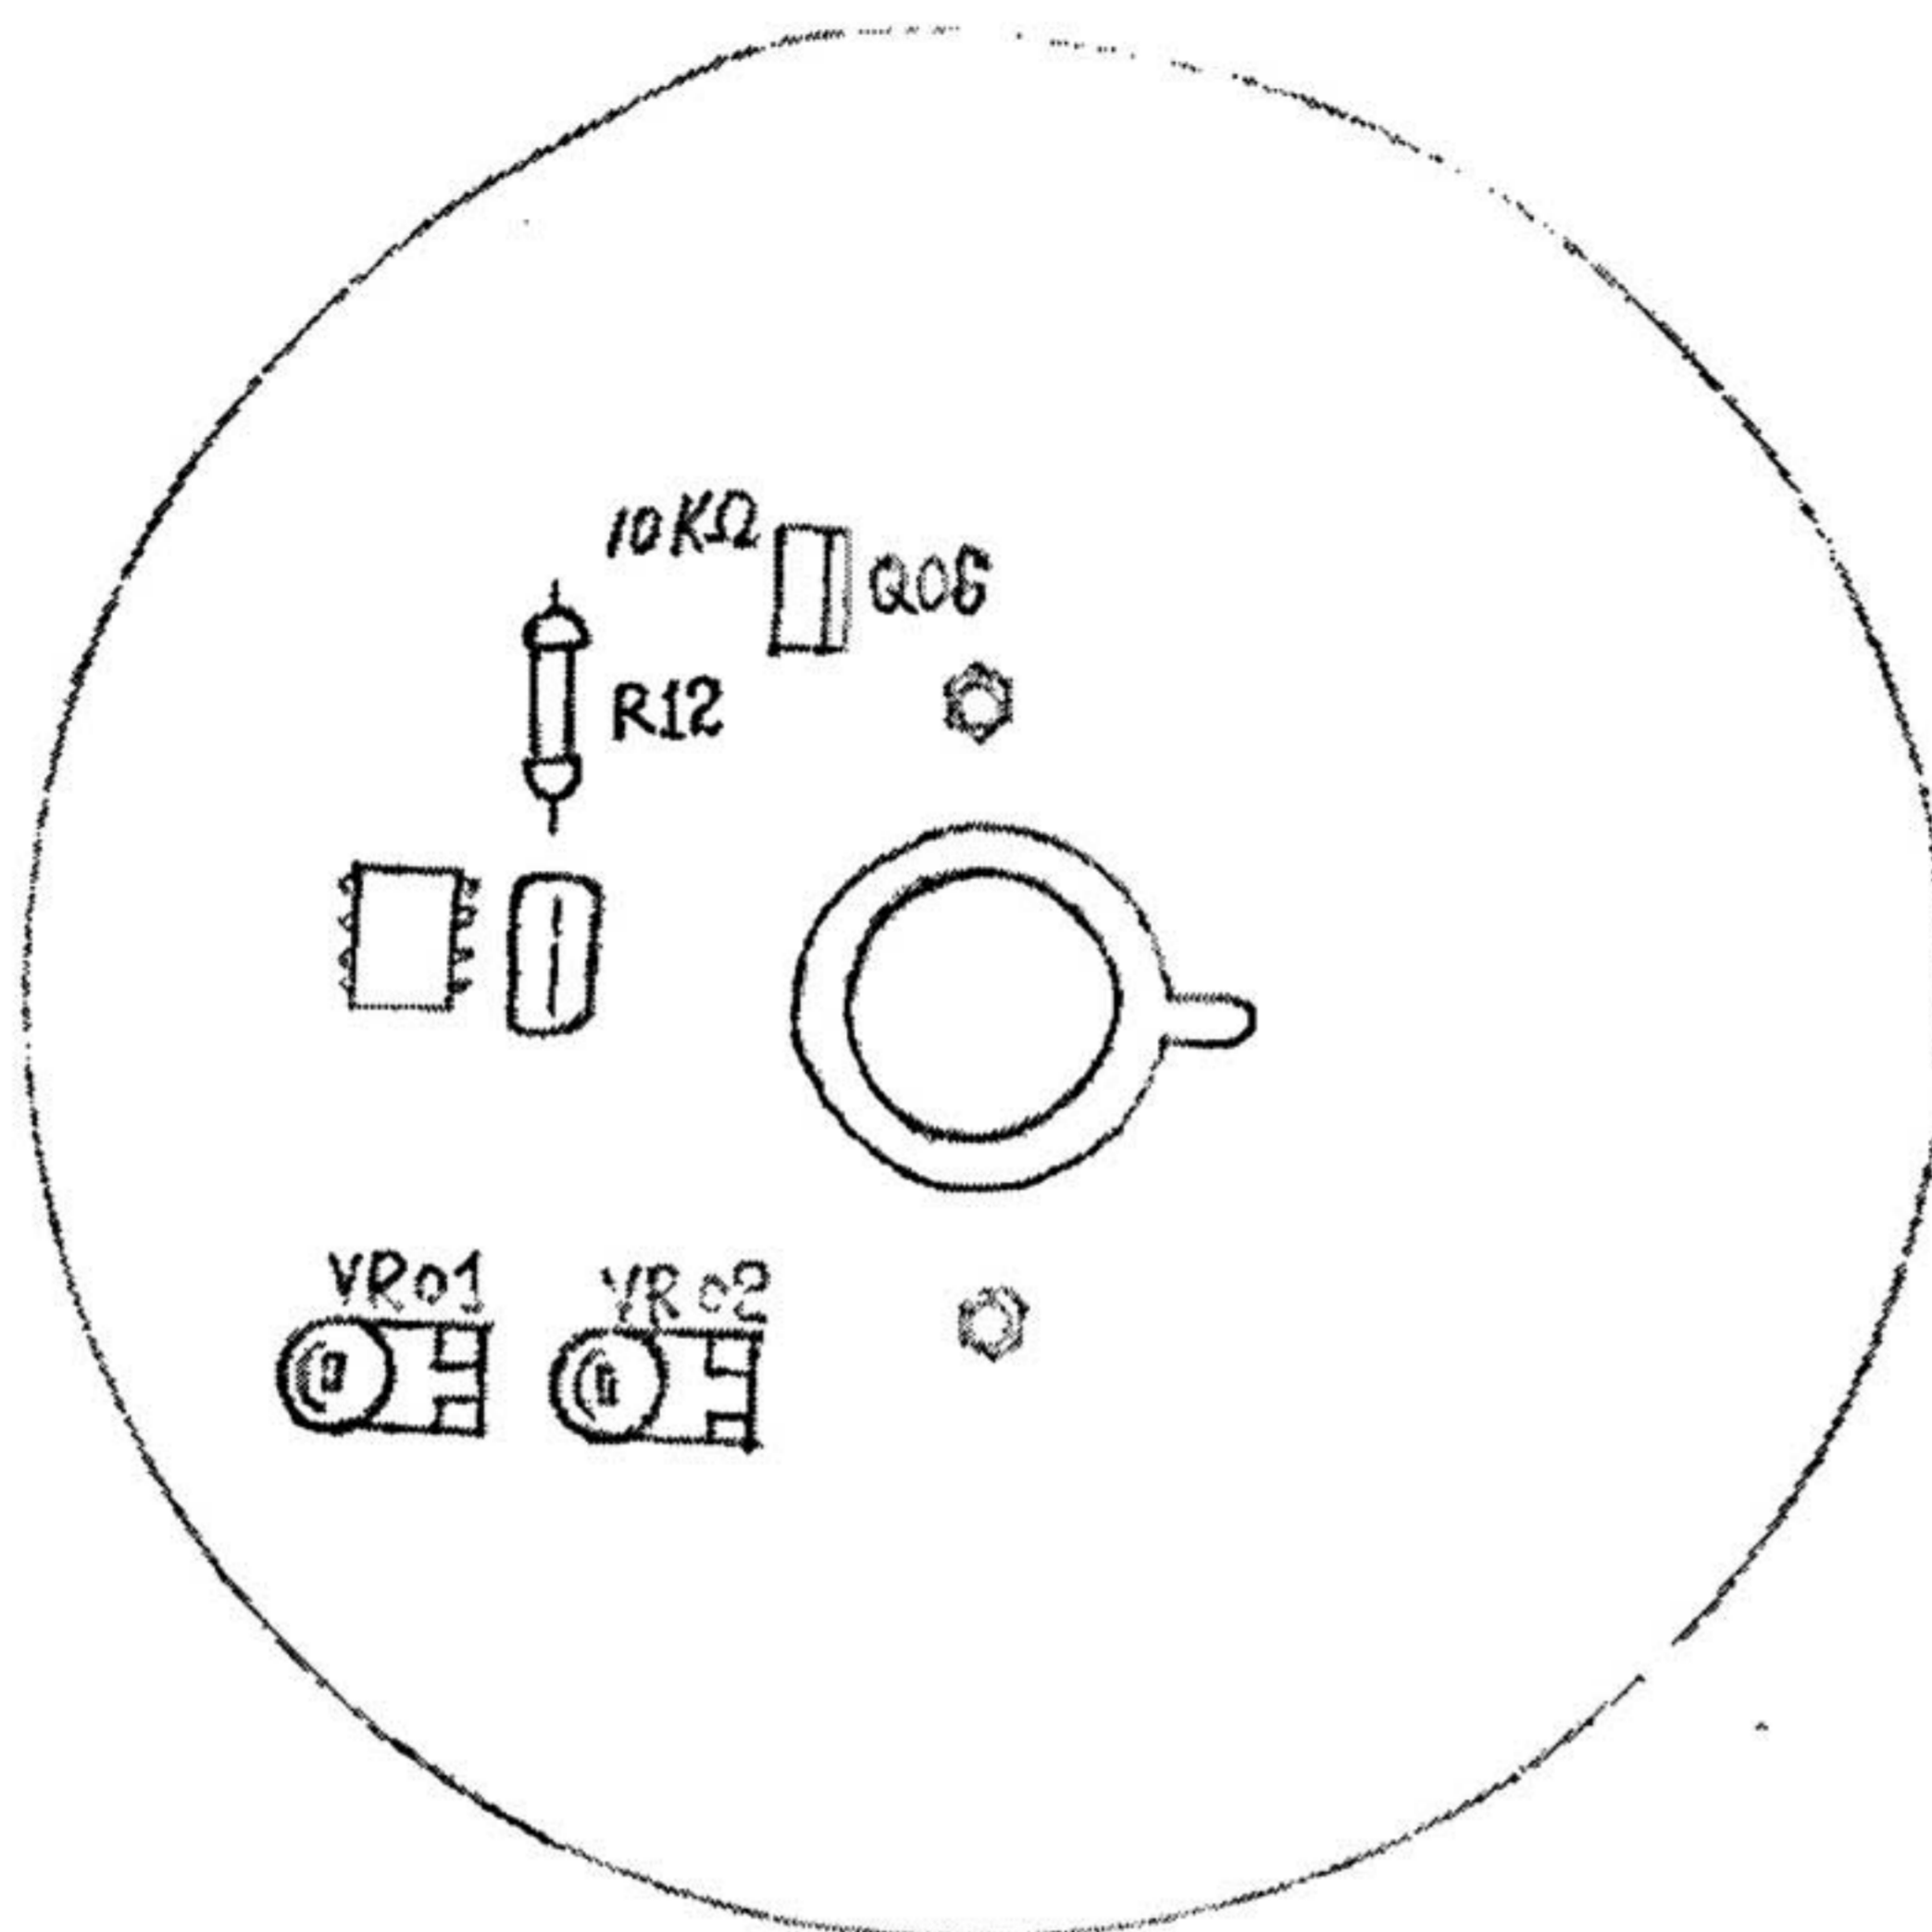
It has been brought to our attention that occasionally, the servo lock system may become intermittent or cut out completely on the PD-441 and PD-444. Should you encounter this situation, the remedial action is as follows:

1. Remove the name plate from the motor cover located on the underside of the unit.
2. Remove the motor cover (be careful not to damage the rubber bushing).
3. Adjust the D.C. voltage on both sides of R12 on the circular Printed Circuit Board to equal:

<u>Speed</u>	<u>Adjustment</u>	<u>Voltage</u>
45 rpm	VR02	8.5v at 10°C (50°F)
33 1/3 rpm	VR01	7.5 volts at 20°C (68°F) 6.0v at 30°C (86°F)

Note: Variable Resistor (VR) must be turned very slowly. 33 1/3 rpm should be set first and then 45 rpm. Also, the platter of the unit must be in place and turning when making this adjustment. I realize that this is difficult but possibly having the unit right side up and reaching underneath to make the adjustment and measurements.
